NASA Contractor Report 174739

High Temperature Low-Cycle Fatigue Mechanisms in Single Crystals of
Nickel-Based Superalloy Mar-M 200

Walter W. Milligan and N. Jayaraman

University of Cincinnati
Cincinnati, Ohio

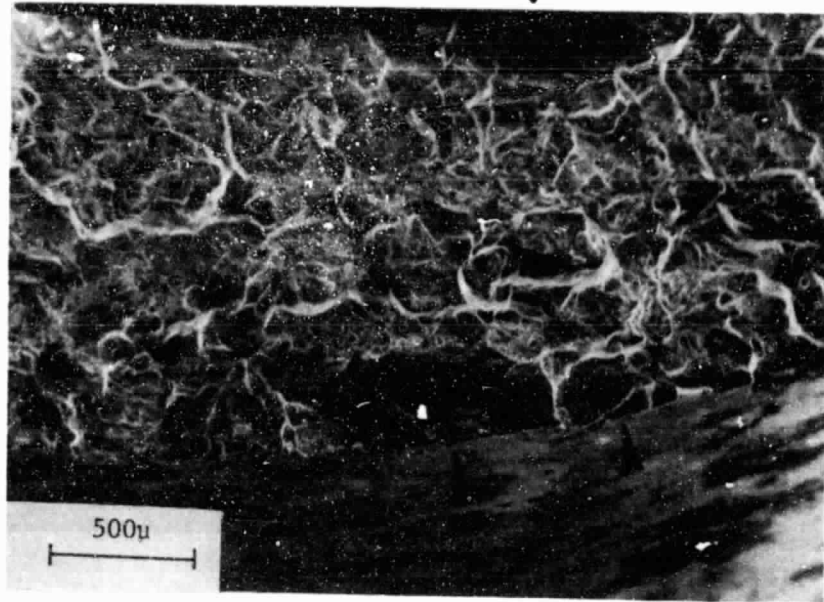
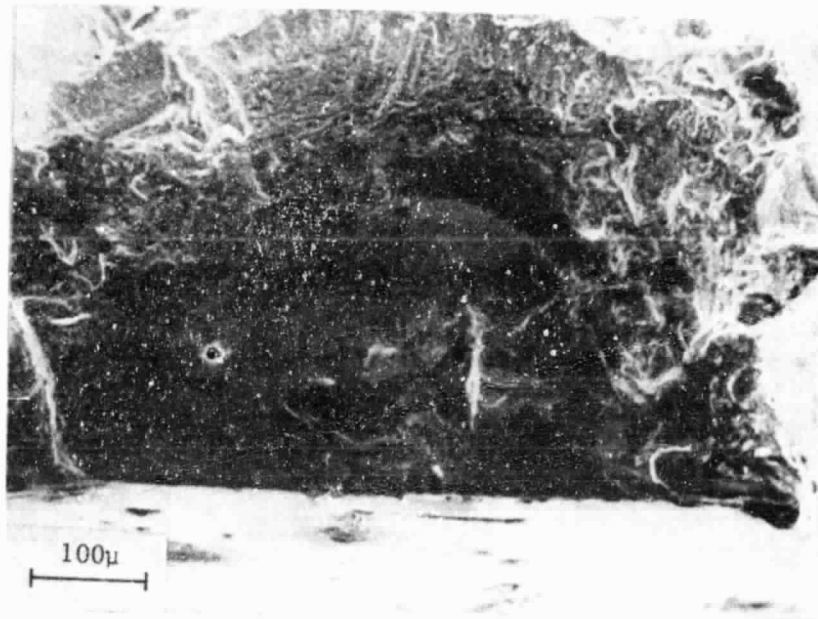
Fig. 25. Increasing magnification SEM fractographs showing smooth initiation zones and clamshell pattern in near (001) orientations at 870°C. Note 3 distinct origins (arrows) in top photo. Specimen FF34, low modulus.

SEM fractography was able to identify a relationship between orientation and crack morphology. Although all cracks initiated at micropores (Figures 25-28) regardless of orientation, the crack propagation mode varied. Orientations near (001) contained distinct, smooth "initiation" zones that exhibited the familiar "clamshell" pattern. (Figure 25). This pattern is typical of low stress propagation. Other orientations exhibited a rougher, more textured fracture surface, which is typical of higher stress propagation. (Figures 26,27). The textured surface

was also observed in the (001) orientations in the later stages of propagation. (Figure 25). No slip traces were observed at 870°C.

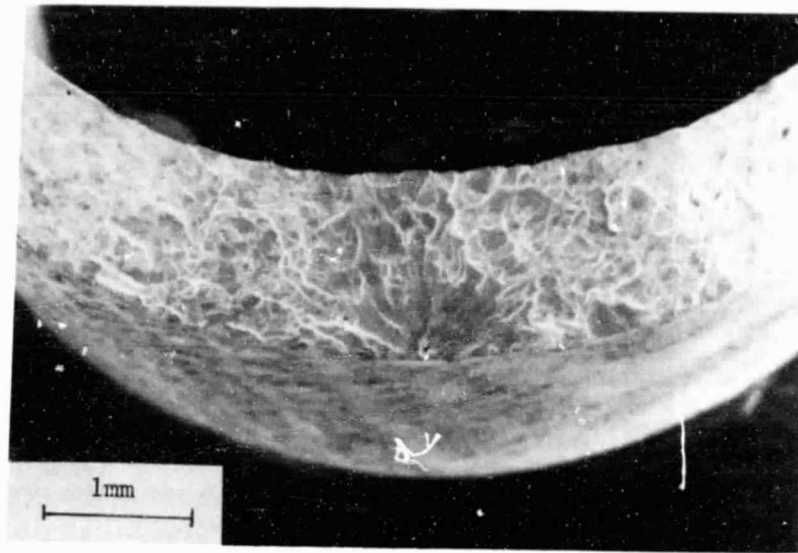
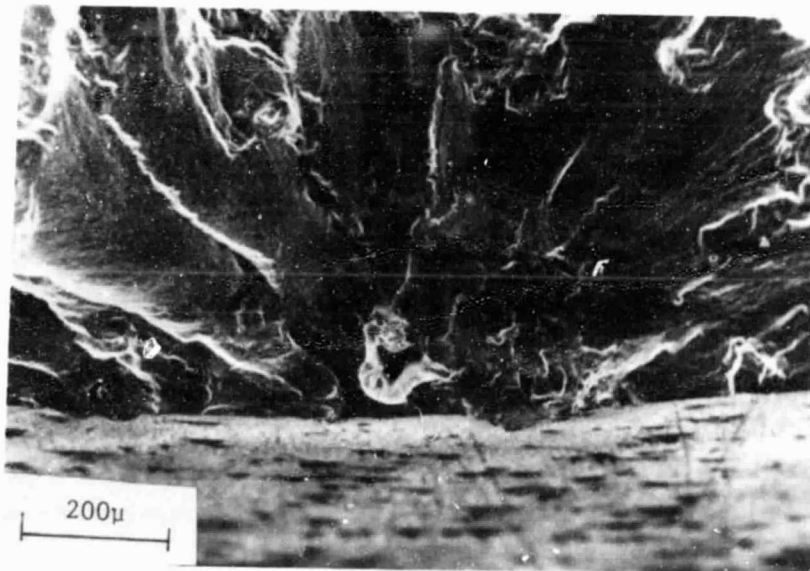
Fig. 26. Increasing magnification SEM fractographs showing initiation at a micropore, and a rougher initial propagation zone. Specimen FF29, intermediate modulus.

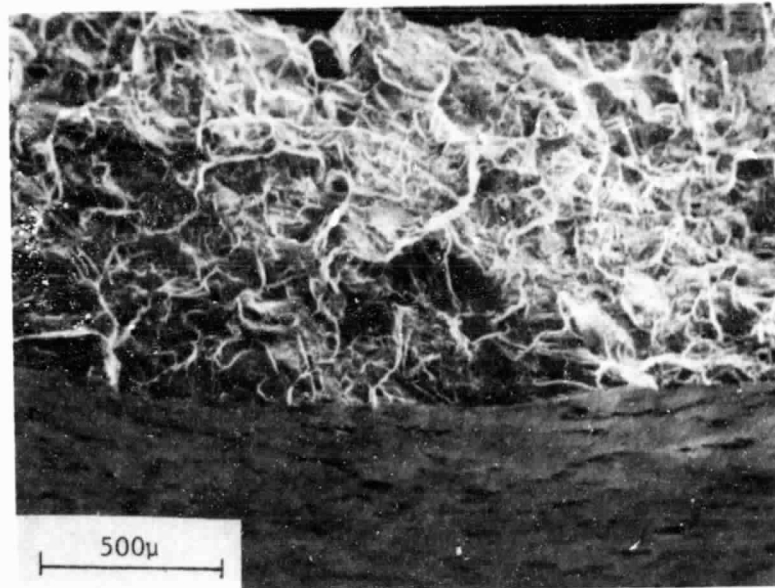
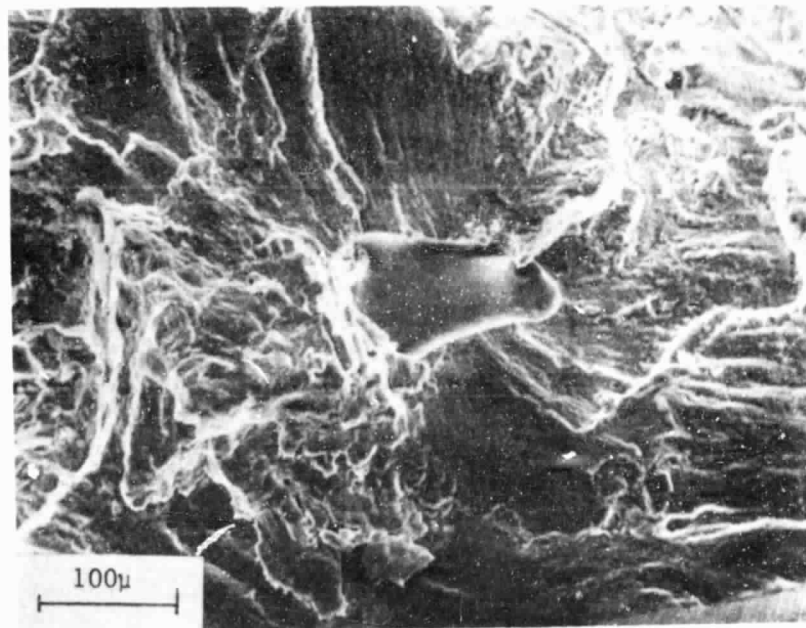
Fig. 27. Increasing magnification SEM fractographs showing initiation at a micropore, and a highly textured initial propagation zone. Specimen FF21, high modulus.

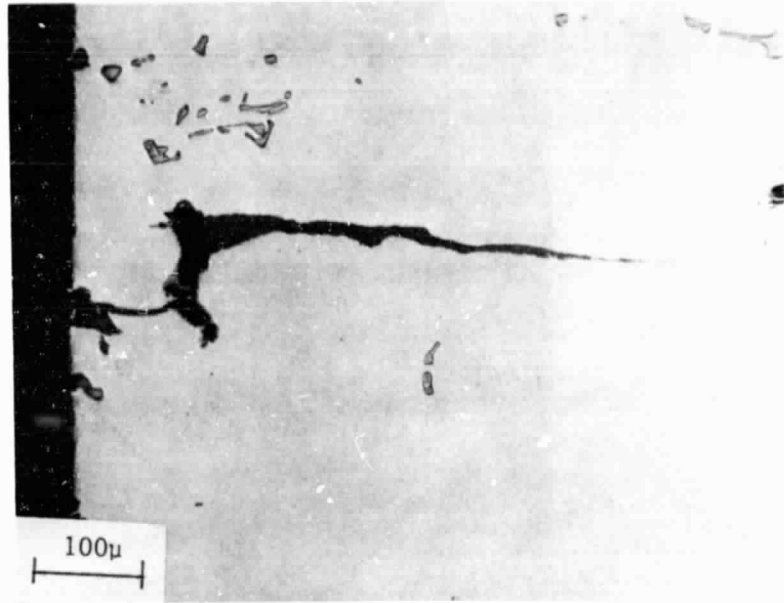
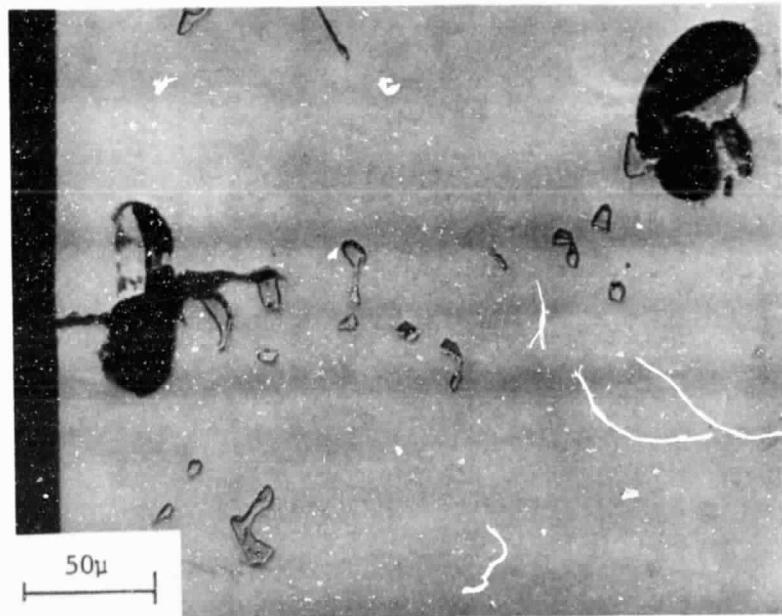
Fig. 28. Photomicrographs showing possible crack initiation at micropores. A) Specimen FF39. B) Specimen FF34.

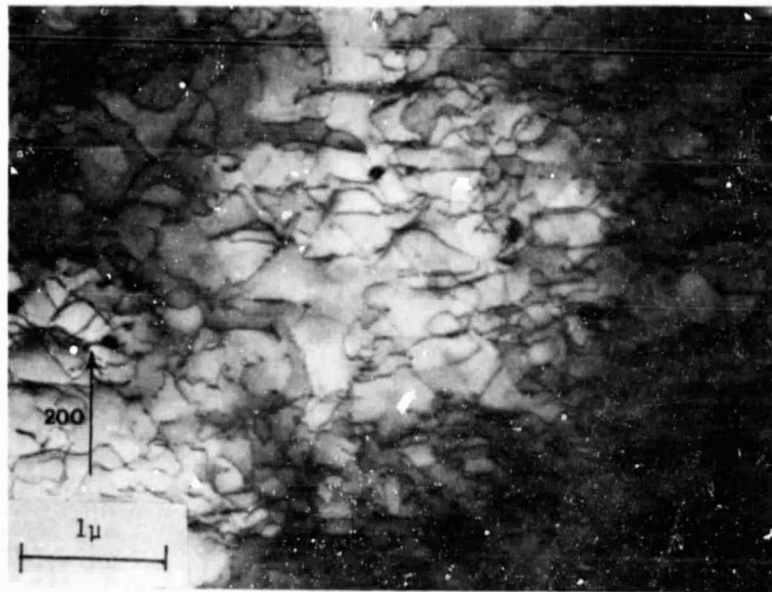
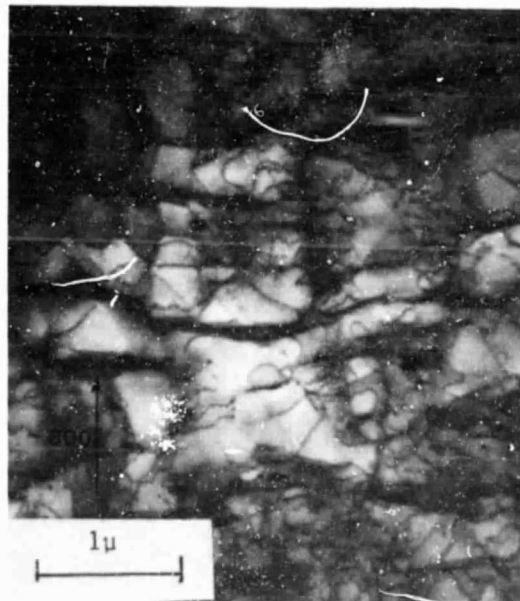
Fig. 29. TEM micrographs of deformation structure after testing at 870°C. Specimen FF21. A) TF showing wavy dislocation structure. B) CDF showing high concentration of dislocations in the γ' .

The most significant observation was that the fatigue microstructure appeared to be independent of orientation. Both octahedral and cube plane dislocations were identified within the γ' in all orientations, but the majority of dislocations were non-linear, and were not confined to one or two planes.

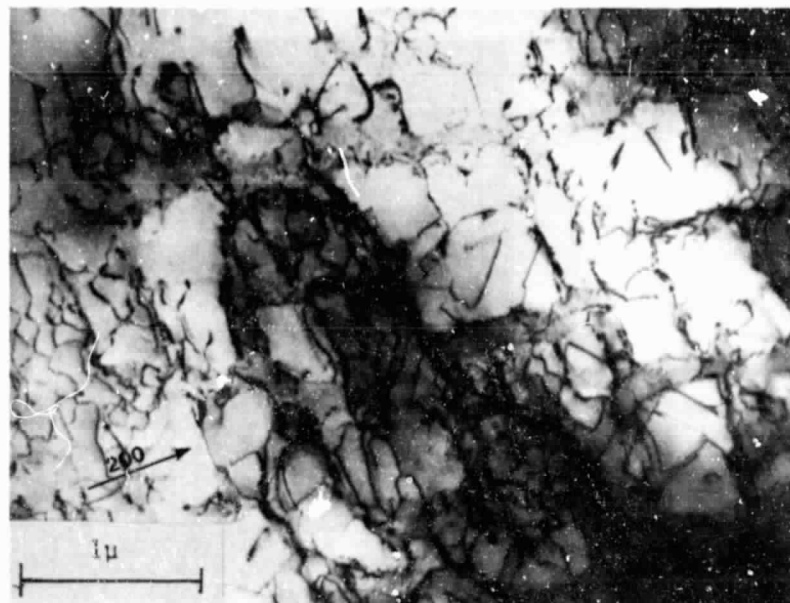
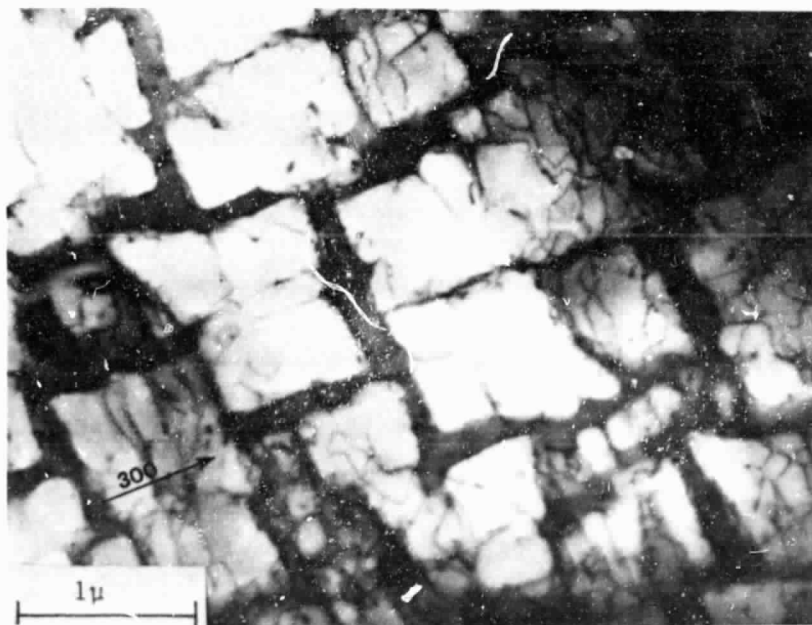
Fig. 30. TEM micrographs, Specimen FF43. A) BF. B) CDF of same area.

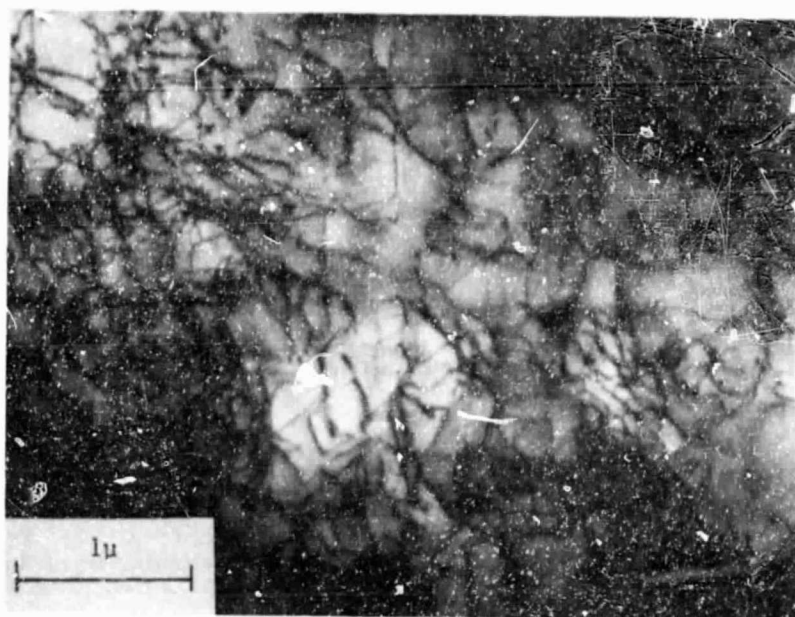
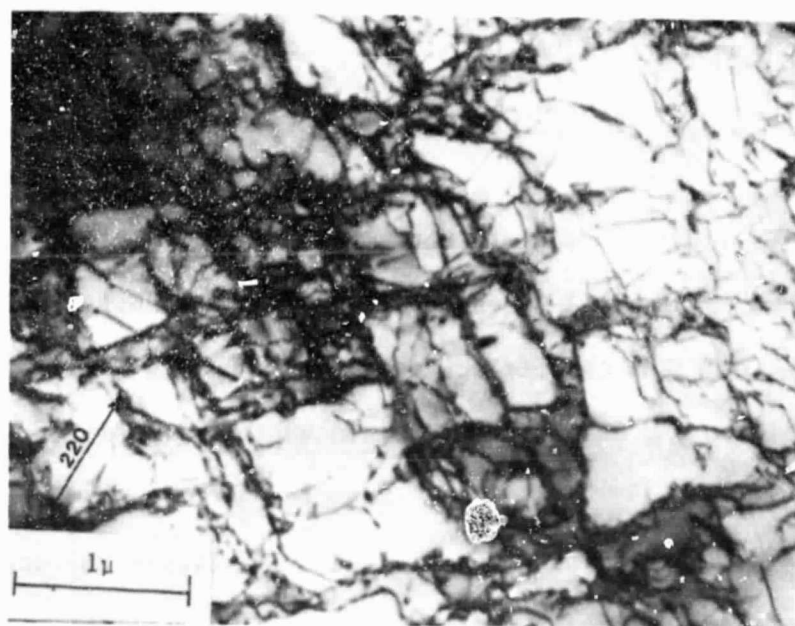
Fig. 31. TEM micrographs illustrating the similarity of the deformation structures in different orientations. A) Specimen FF21. B) Specimen FF48.

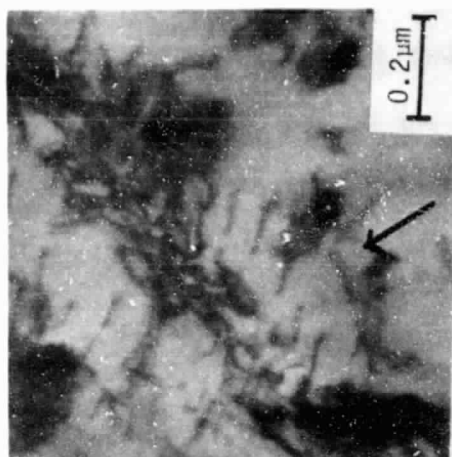
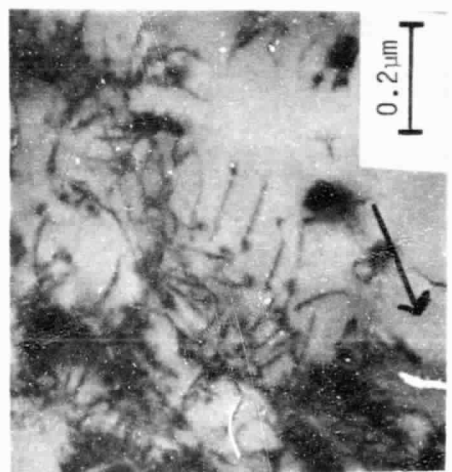
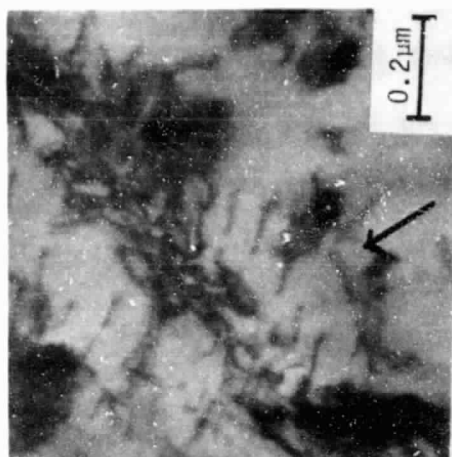
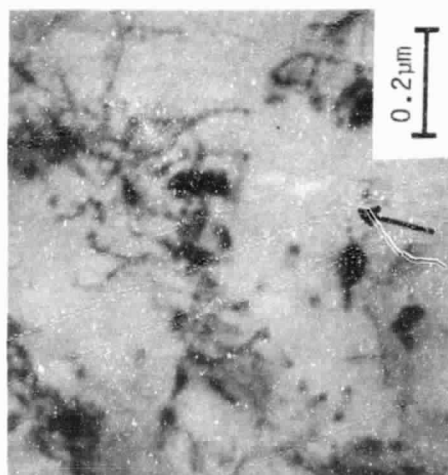
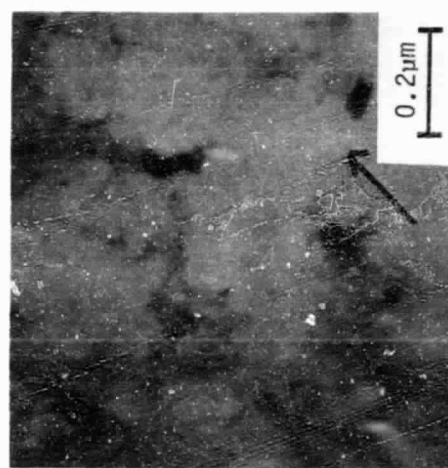
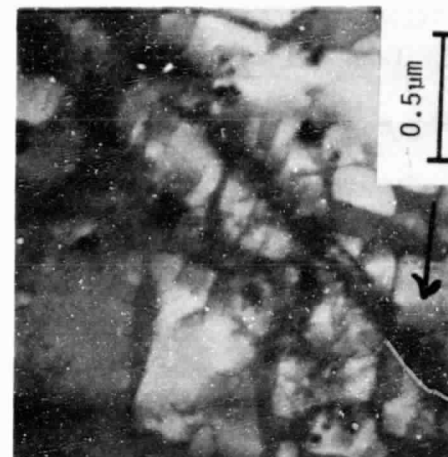
Fig. A1. TEM micrographs illustrating the dislocation analysis technique. (a) - (e) are BF micrographs of the same area under different operating reflections. (f) is a lower magnification CDF of the same area.

The slip band in Specimen FF27 (Figure 23) was documented under 5 different two-beam conditions (Figures A1-A5). Two observed dislocations are present under three of these conditions (A1-A3), but disappear under the two other conditions (A4,A5). The two invisible diffraction conditions are: $\underline{g}_1 = (1\bar{1}1)$ and $\underline{g}_2 = (200)$. The burgers vector is defined as $\underline{g}_1 \times \underline{g}_2$, or (011) .

diffraction conditions. The only direction that satisfies all three conditions (within experimental error) was $\underline{u} = (010)$.

Since $\underline{b} \neq \underline{u}$, the dislocation is not pure screw, and the slip plane is defined by $\underline{b} \times \underline{u} = (100)$. These dislocations are therefore of the type $a/2 [011] (100)$.
